SARDIS: ARCHAEOLOGICAL RESEARCH AND CONSERVATION PROJECTS IN 2006

Crawford H. GREENEWALT*

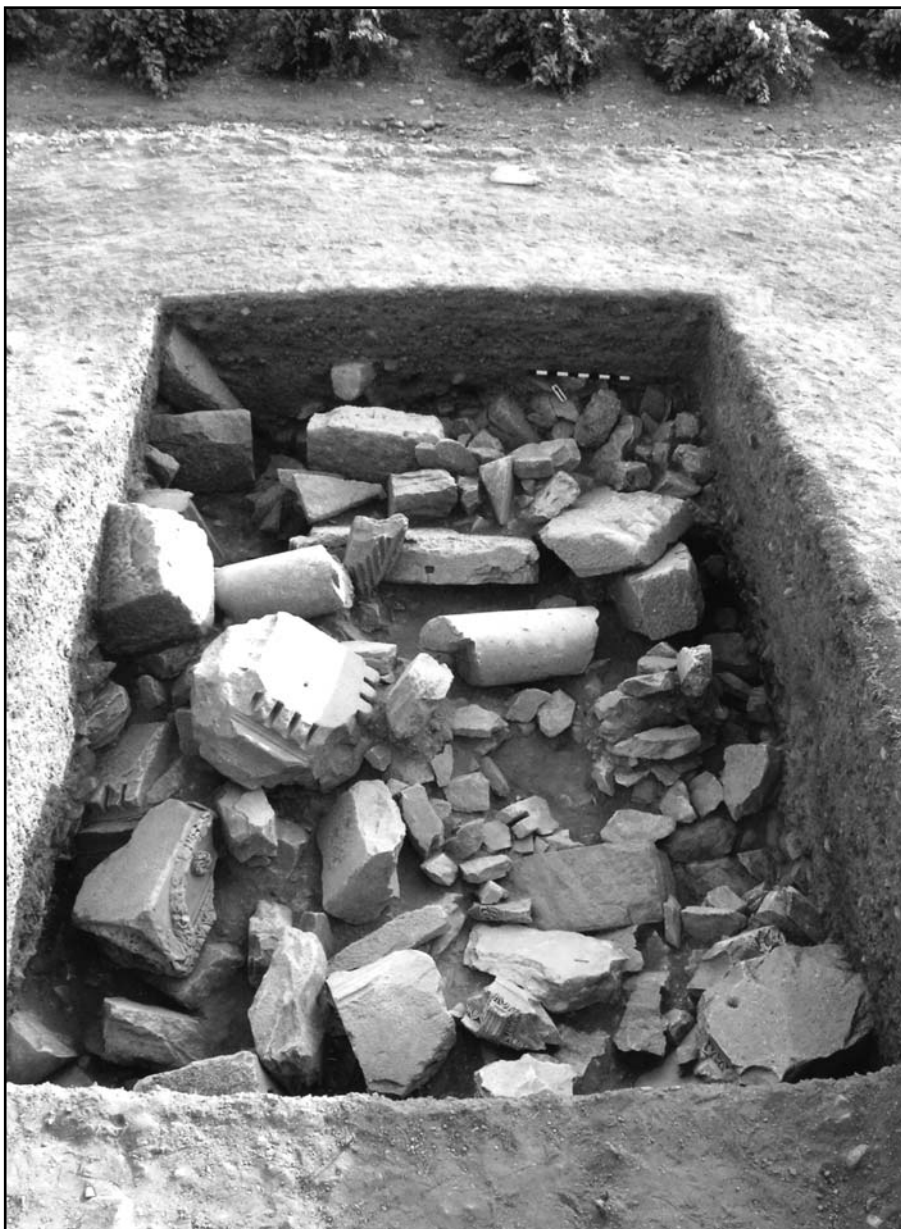
Fig. 5: Sardis, Theater, *scaenae frons* fragments (as exposed in trench 06.4); view looking north

A monumental stage façade (*scaenae frons*) survives as a tumble of fallen fragments (exposed in two trenches at its east end; Fig. 4; nos. 06.3 and 06.4; Fig. 5), which belonged to an aediculate two- or three-story construction; those façade remains show that the Theater *cavea* could never have been used for viewing activity in the Stadium when the façade existed. Component parts, mostly of white marble, included columns (smooth shafts of white and red brecciated stone and granite; Asiatic Ionic bases and composite capitals), entablatures with standard ornament (e.g., dentils, modillions, pulvinated frieze, simas with palmette chain; Figs. 6-7)); doorway jambs or lintels, niche frames (to which one fragment

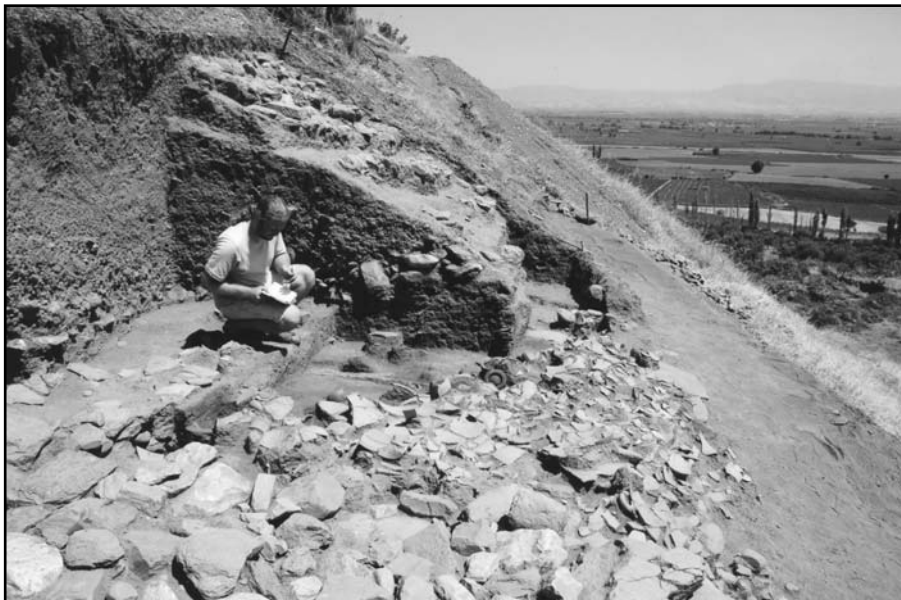
Fig. 11: Sardis, Theater: upper cavea, east "arm" (trench 06.2). Theater seat foundations (above) and Archaic house remains (below); view looking north

Dismantling of seat construction in the *cavea* is attested by marble seat blocks resting in earthy debris above the lower *cavea* and *orchestra* (Fig. 4, trench 06.1), and by remnants of seat foundations (made of mortared fieldstones) in the east side of the upper *cavea* (Figs. 4, trench 06.2; 11, 12). Even those seat foundations survived in only part of the excavation trench in which they were exposed (06.2); in the rest of that trench, the uppermost exposed part of the Theater consisted of earth fill that had supported seat foundation - and that helped to create one artificial "arm" of the semi-circular *cavea*, (i.e., where it extended beyond the natural Acropolis slope).

From the first morning of excavation, this trench (06.2) produced fragments of Archaic (Lydian) pottery, of the 6th century B.C.; at first dismissed as fortuitous ‘flotsam and jetsam,’ they soon proved to belong to a 6th century deposit (Figs. 11-13) that rested on an Archaic occupation surface. The surface belonged to an Archaic house, built on a terraced slope of the Acropolis, before the slope had been amplified with fill to create the Theater *cavea*. The part of the house excavated in 2006 evidently belonged to something like a kitchen or pantry, to judge from the artifacts; which included several grinding stones, five or six pyramidal loom weights, “bread trays,” cooking pots of the *chytra* type, storage and table amphorae, column craters, an oinochoe, skyphoi, stemmed dishes, one-handled cup, juglets and flasks - all in all perhaps about fifty items; of which only a few of the ceramic items could be reconstructed in the time available (Fig. 14). Intense burning everywhere indicates that this part of the house had been destroyed by fire; the presence in the debris of weapons – two arrowheads and spear head; dagger (also a knife; Fig. 15) is evidence for conflict; and all the material appears to be compatible with a date in the first half of the 6th century B.C. (no Achaemenid Bowls or “late” column craters are present). Burning and weapons, therefore, might attest destruction by the Persians, in the 540s B.C., as is evidently attested at the western limits of the city core (at sectors MMS/N, MMS, MMS/S). On the other hand, the burning could have been accidental (a consequence of uncontrolled cooking fire); weapons might belong to hunting equipment; and the date of destruction is far from clear (no chronologically diagnostic imported materials were recognized).

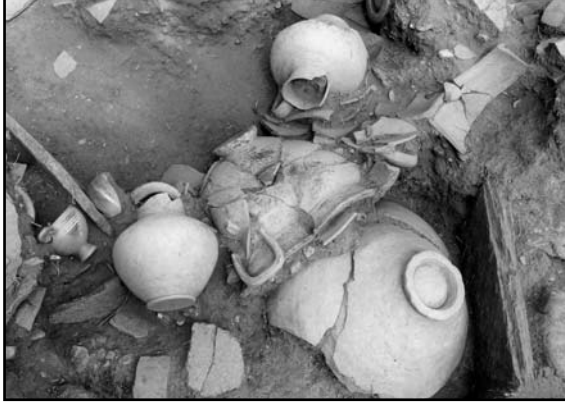
Fig. 13: Sardis, Theater: upper cavea, east "arm" (trench 06.2). Archaic house remains, ceramic items *in situ*
